REHABILITATION OF NAVIGATION LOCK WALLS: CASE HISTORIES

James E. McDonald

December 1987

Final Report

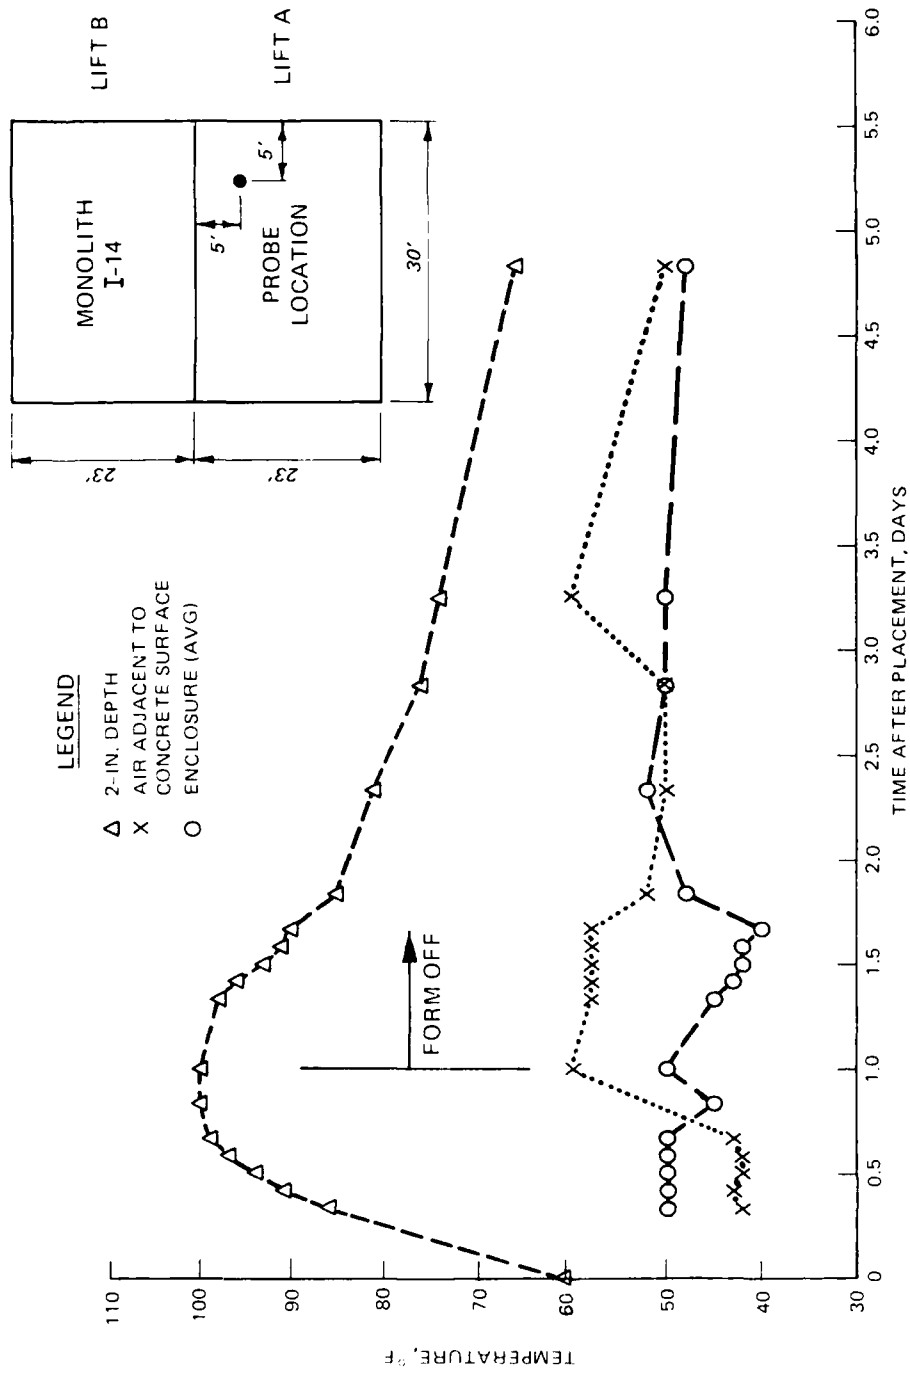
Figure 102. Results of temperature monitoring, mixture 510-4PA5, placement I-14A, Lock No. 1, Mississippi River

reduced the temperature differential between air adjacent to the surface and at 2-in. depth inside the concrete to 22°F. Similar results were obtained for placement I-14A (Figure 102). The form was removed one day following placement, subjecting the concrete to a temperature differential between ambient and 2-in. depth of 55°F. After the concrete surface was covered with polyethylene, the temperature differential between air adjacent to the surface and concrete at 2-in. depth was 40°F. This temperature differential decreased with time; however it remained in excess of 25°F for approximately two days. Although no cracks were reported for either the L-11A or I-14A placements, it is quite possible that they were present but not observed because of the polyethylene covering. Later reports that most placements contained cracks would appear to substantiate this possibility.

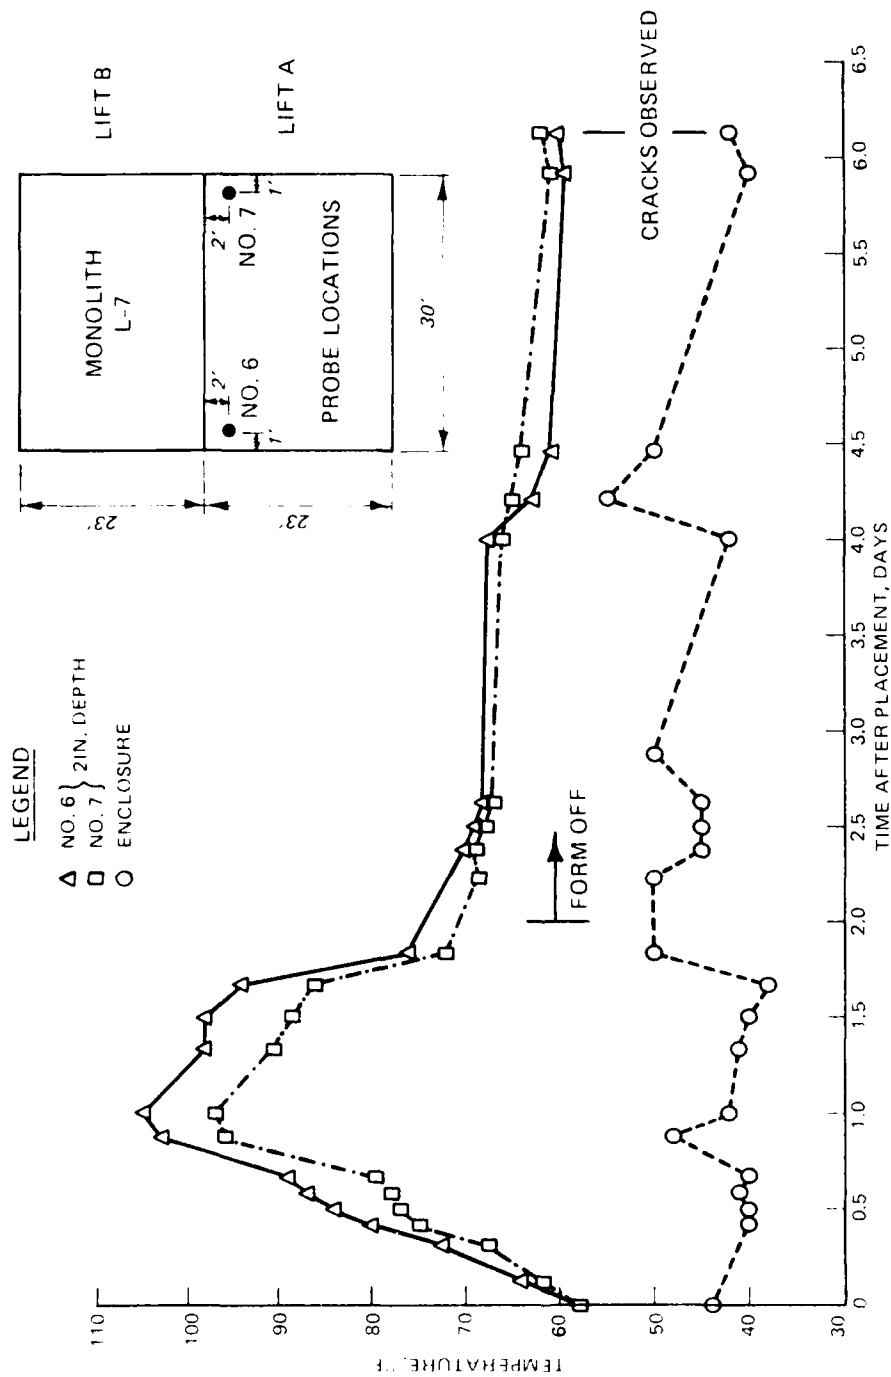
230. Results of the temperature monitoring of placement L-7A are shown in Figures 103 and 104. The peak temperature recorded, 24 hr following placement, was 96°F, which represented a heat rise of 38°F. From removal two days after placement, the concrete was subjected to a temperature differential between ambient and 2-in. depth of 25°F. This differential decreased only slightly during the remainder of the curing period. Cracking similar to that previously observed in the conventional concrete resurfacing was reported. The cracks were not observed until the end of the curing period.

Figure 103. Results of temperature monitoring, mixture CC552-4PA5, placement L-7A, 9 ft below top of lift A, Lock No. 1, Mississippi River

Figure 104. Results of temperature monitoring, mixture CC552-4PA5, placement L-7A, 2 ft below top of lift A, Lock No. 1, Mississippi River

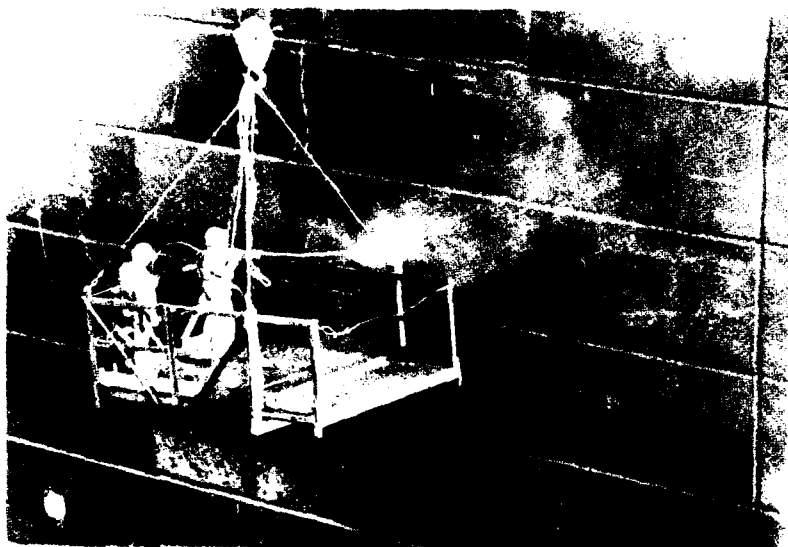
Figure 112. Removal of unsound concrete mortar using a high-pressure water jet, Lower Monumental Lock

the lock chamber walls. Since the success of the repair was totally dependent upon satisfactory surface preparation, several additional surface cleaning trials were made to verify that with properly operating high-pressure water-jet equipment, the surface could be satisfactorily cleaned. Sandblasting equipment, wire brushes, hand chipping, and air-operated scabblers were also tried by the Government designers. The benefit of this experience was passed on to the bidders through a prebid conference, discussion in the technical provisions of the bidding documents, and with photographs of the work (Figure 112) which also became a part of the bidding documents.

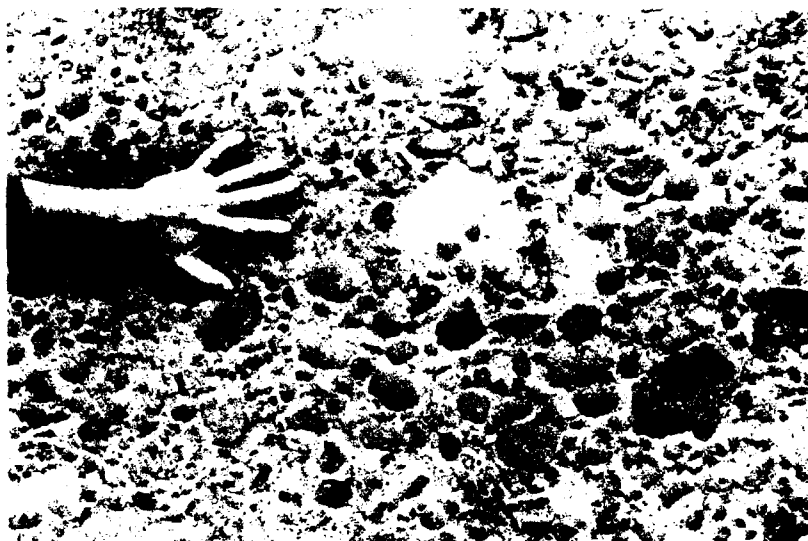
259. Most of the actual cleaning was done between lockages over a three-week period before the lock outage and actual spray-up coating operations began. High-pressure water-jet equipment was used and normally operated at about 10,000 psi. As the nozzle tips would wear out, the pressure would start to drop to about 7,000 psi. New tips were then installed. Both the pressure and angle of the jet were critical to effectively remove unsound materials. Occasional handchipping was used to supplement the water jet in areas where it just did not clean well enough. Usually the unsound mortar was about 1/4- to 3/8-in. thick and flaked off easily (Figure 113). For most of the area in the lower portion of the lock, scaling had already occurred to a depth of 1/2 to 2 in. in the mortar, severely exposing the large aggregate which itself was quite sound. An example of the wall surface after acceptable surface preparation is shown in Figure 114.

Figure 114. Typical condition of the wall following acceptable surface preparation, Lower Monumental Lock

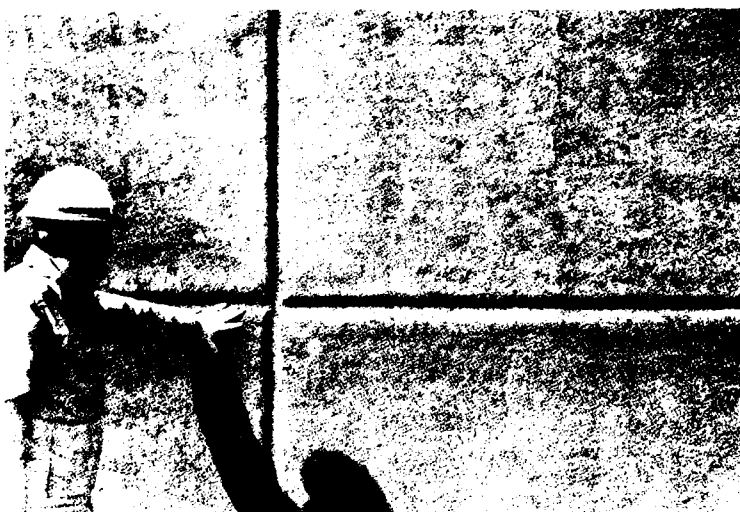
268. The thickness of the in-place coating (Figure 118) varied between 5/16 and 5/8 in. and averaged 3/8 in. In areas where 3-in. aggregate was visible on the lock wall, the thickness over the outside of the 3-in. cobbles was less than 3/8 in., but between the aggregate particles it was more than 3/8 in. Since protection over the mortar between the aggregate was most important, this thickness was considered acceptable. Thickness was continuously checked by stabbing the wet mix with a nail used as a depth gage.

a. Coating of rough, severely deteriorated concrete

b. Coating in the upper lifts which had minimal concrete deterioration

Figure 118. Typical appearance of the wall coating, Lower Monumental Lock

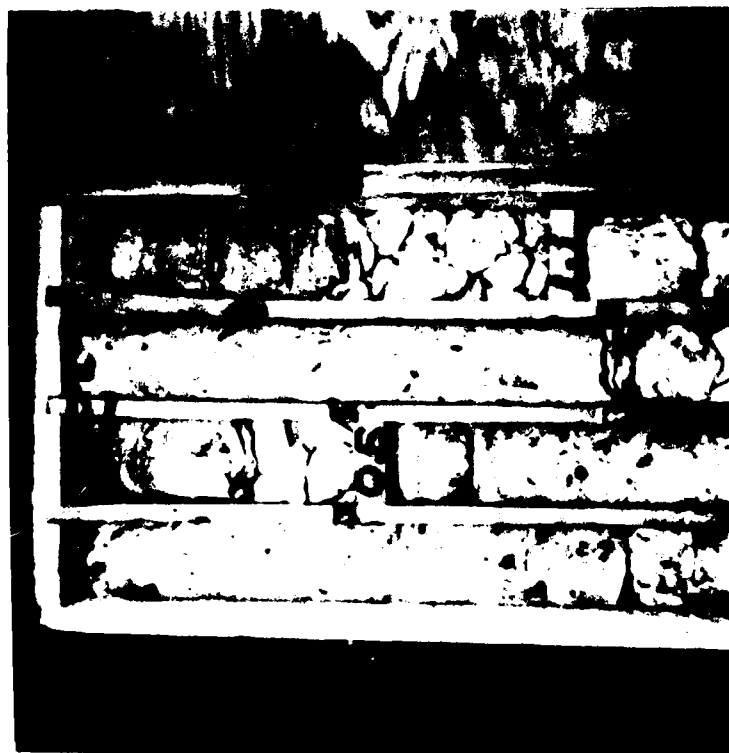
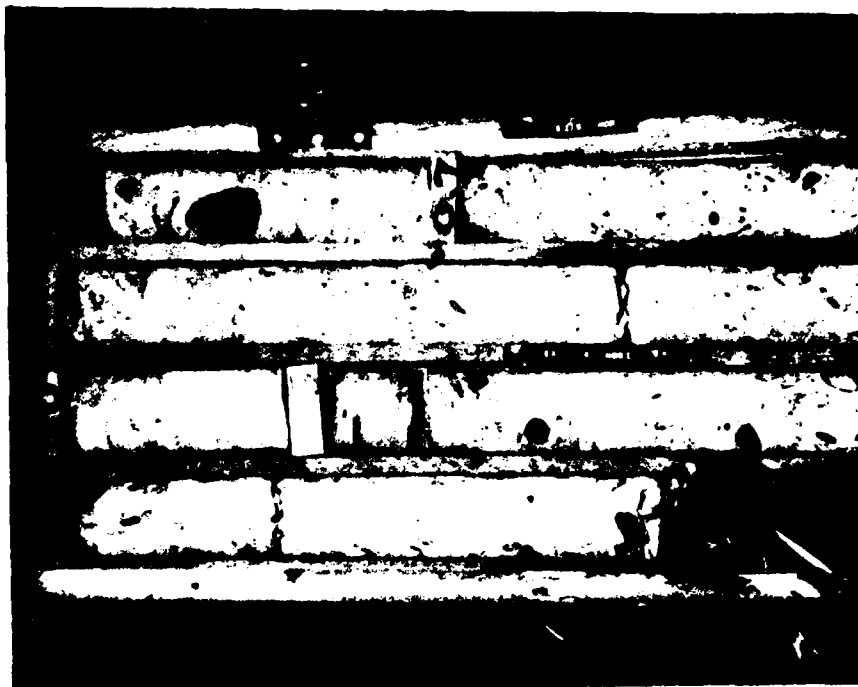
Figure 130. Horizontal cores taken from the river chamber walls, 1973, Emsworth Locks

288. During this inspection, horizontal cores drilled from the lock chamber walls in 1973 were compared. Cores from the river chamber showed the shotcrete to be in generally good condition (Figure 130); however the original concrete behind the shotcrete exhibited significant deterioration probably caused by cycles of freezing and thawing. Cores of similar concrete from the land chamber which were not coated with shotcrete were in generally good condition from the surface inward (Figure 131). These cores appear to be an example of an exterior coating contributing to the saturation of the original concrete with increased deterioration caused by frost action as a result.

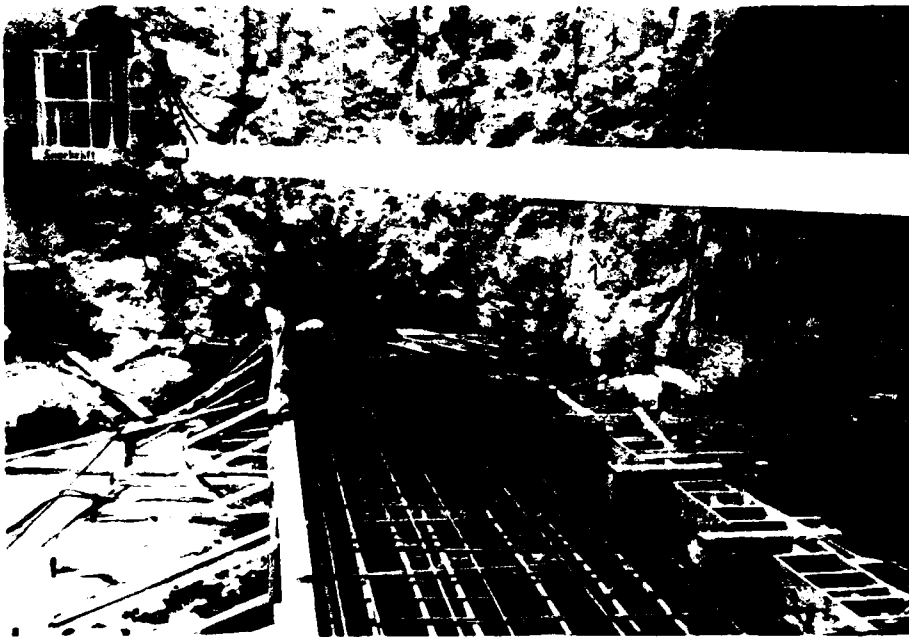
Figure 140. Miter gate sill and anchorage, modifications,
Lockport Lock

313. The major effort in the rehabilitation of Lockport Lock involved the lower miter gates. The lock was closed to navigation on 5 July 1984, and the first operation prior to placement of the dewatering bulkheads was removal of the existing 315-ton, 60-ft-high miter gate leaves. This operation was accomplished by use of a barge-mounted derrick crane before the lock was dewatered. The miter gates were replaced with a modern all-welded steel design, which required rebuilding of the sill and the embedded (quoin) anchorage. The new sill (Figure 140) required concrete and rock removal, prestressed anchors, and installation of new embedded metals for the new seals. Water leakage through the sill required the installation of a well point system to intercept all water coming from joints and planes in the bedrock. The new quoin anchorage required removal of concrete around and including the existing quoin (Figure 141). The contract required removal of this concrete by nonblasting techniques because of the sensitivity of the area. The contractor chose to drill lines of small diameter holes along the top of the lock walls parallel to the lock chamber and to fill alternating holes in the row nearest the chamber with S-mite, an expansive grout. This attempt to presplit the concrete along the drill line resulted in cracks in the concrete which were very erratic in both direction and extent. Cracking behind the quoin anchorage area was of particular concern.

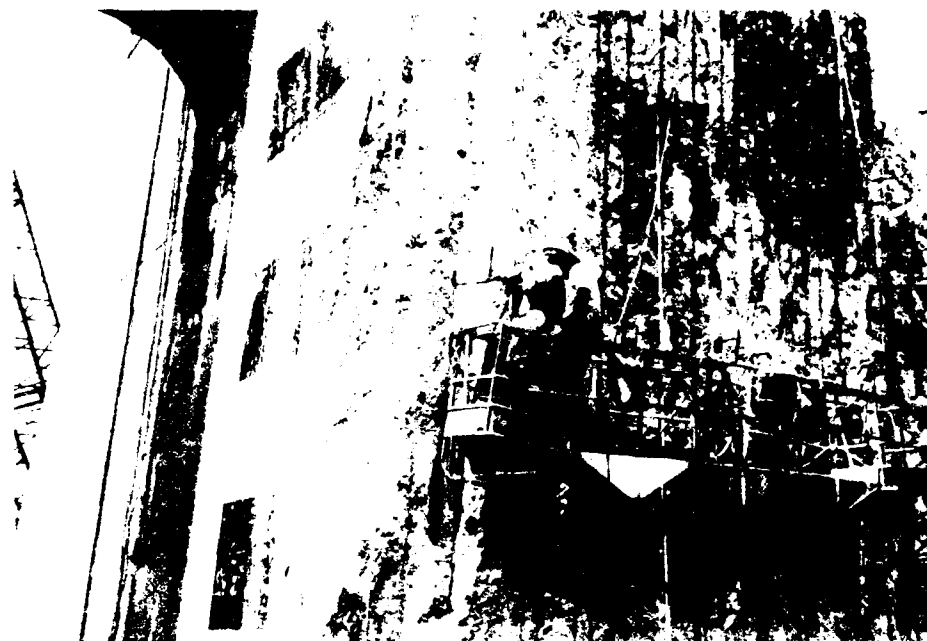
Figure 161. Rehabilitation of lower gate bay, Lockport Lock

a. Installation of dowels

b. Crack in top of culvert to be grouted

325. Since the condition survey showed that the maximum depth of concrete deterioration occurred in the lower gate bay, it was completely refaced during the Stage I rehabilitation. The refacing required removal of approximately 335 cu yd of concrete and replacement with new armored concrete. Approximately 960 dowels were required to anchor the replacement concrete (Figure 161). Bid prices for these dowels ranged from \$33 to \$74 each compared to the Government estimate of \$34. A roughly vertical crack which extended from the top of the emptying culvert for a distance of approximately 18 ft was pressure-grouted prior to placement of the new concrete.

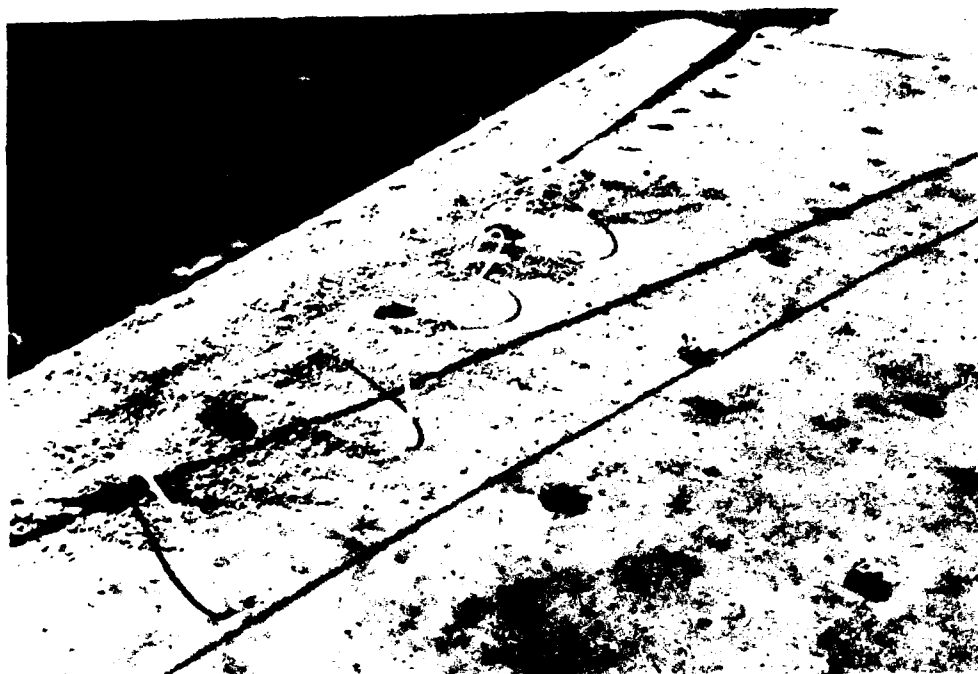
Figure 165. Concrete removal by blasting, Brandon Road Lock

a. Primacord inserted into predrilled holes

b. Detonation

preparations for concrete removal by line drilling a series of 2-1/2-in.-diam holes on 9-in. centers along the top of the lock wall. These vertical holes were located between 15 and 24 in. back from the chamber face and were drilled to a depth of 40 ft. Brandon Road Lock was closed to navigation on 5 July 1984, coinciding with the closure at Lockport Lock. Immediately after the lock was dewatered, a horizontal saw cut 7 in. deep was made along the lower work line, approximately 2 ft below low-water pool, to control overbreak during concrete removal. Also, the bottom 2 ft of the holes was stemmed with sand to prevent overbreak. The contractor then inserted 100-grain/ft detonating cord with blasting caps into the holes, plugged the top of the holes to prevent loss of energy, and detonated the explosives with an electrical charge (Figure 165). Blasting was restricted to one 30-ft monolith at a time.

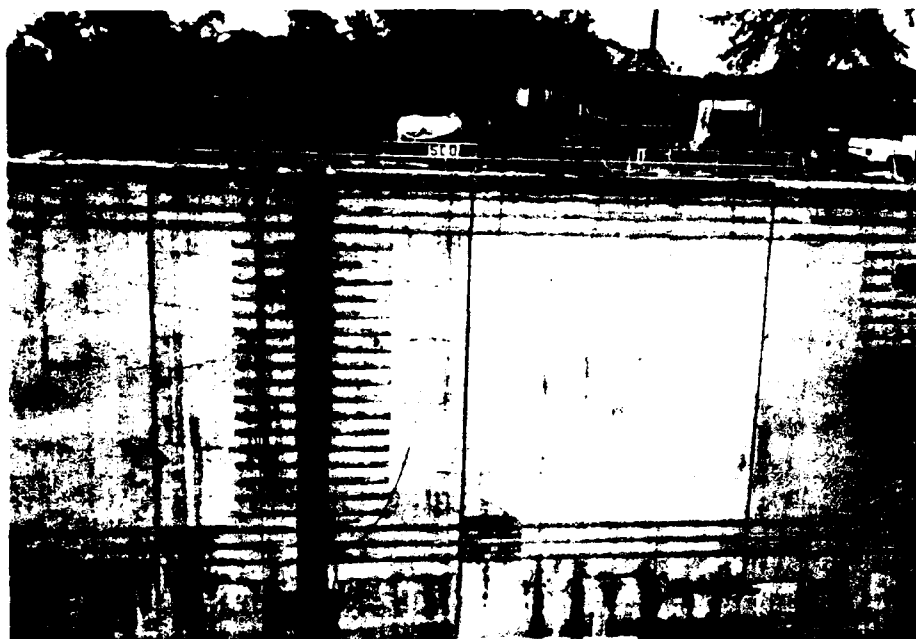
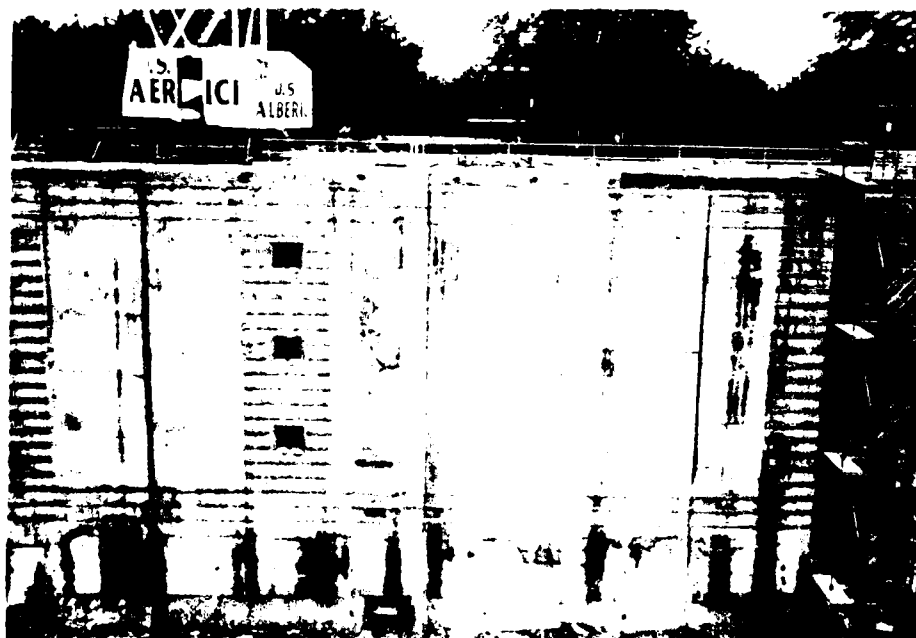
Figure 179. Typical cracking in the replacement concrete
August 1984, Brandon Road Lock

a. Landside wall

b. Riverside wall

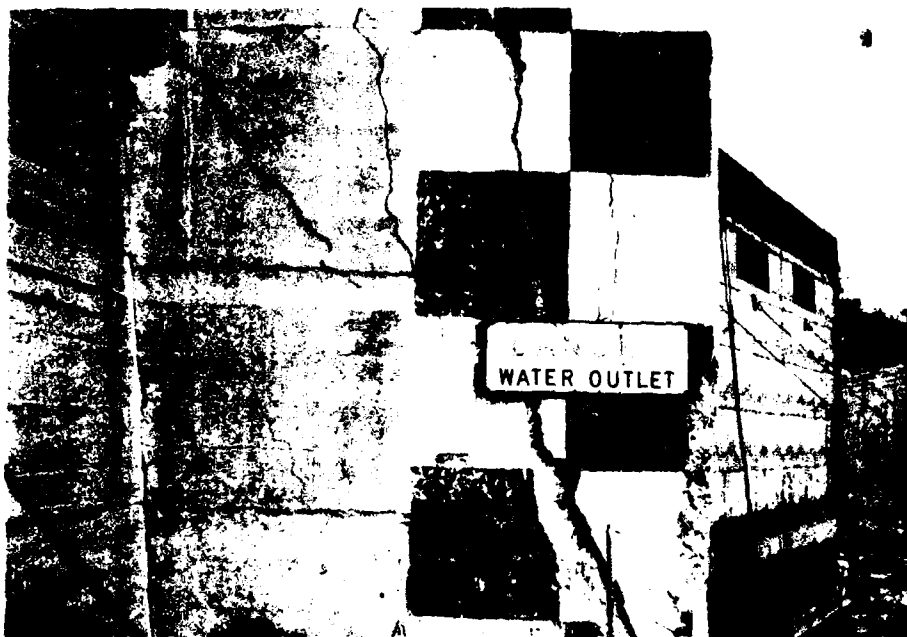
these areas was prohibited in the original design. In these areas, the removal line was drilled much the same as for blasting, and the contractor elected to use expansive grout (S-Mite) to fracture the deteriorated concrete face (Figure 181). A crack developed behind the quoin anchorage similar to what had happened at Lockport Lock. Initially, the fractured concrete was removed with handheld and machine-mounted breakers (Figure 182). This method proved to be very time-consuming. In an effort to increase production, removing some of this concrete with explosives was allowed. In these cases, removal was limited to approximately 5-ft intervals for each blast (Figure 183) as compared to full monolith face removal in the lock chamber. Ultimately, the Cutter Boom proved to be extremely effective in grinding off the fractured concrete in these areas (Figure 184). The contractor's bid price for removal of concrete in these areas ranged from \$216 to \$675 per cu yd with an average of \$413 per cu yd. This average cost was approximately 2.5 times the cost of concrete removal in the lock chamber resurfacing.

Figure 181. Examples of deteriorated concrete fractured using expansive grout, Brandon Road Lock

342. The crack behind the quoin anchorage area was pressure-injected with epoxy grout, and the cracked section was anchored to the main concrete mass with reinforcing steel. The entire area was then resurfaced with an overlay of anchored concrete. No visual structural problems have been noted

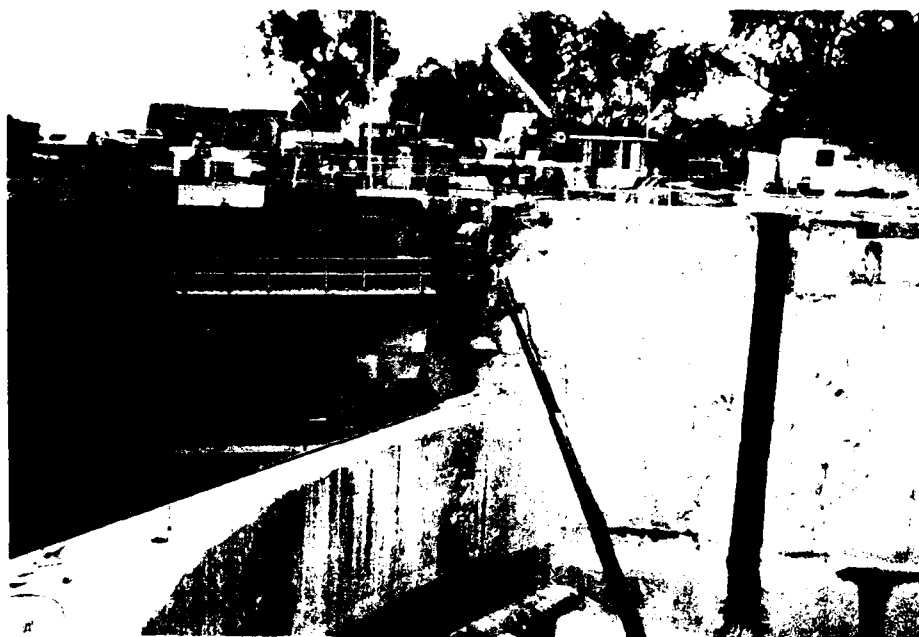
Figure 182. Concrete removal near upper miter gate,
Brandon Road Lock

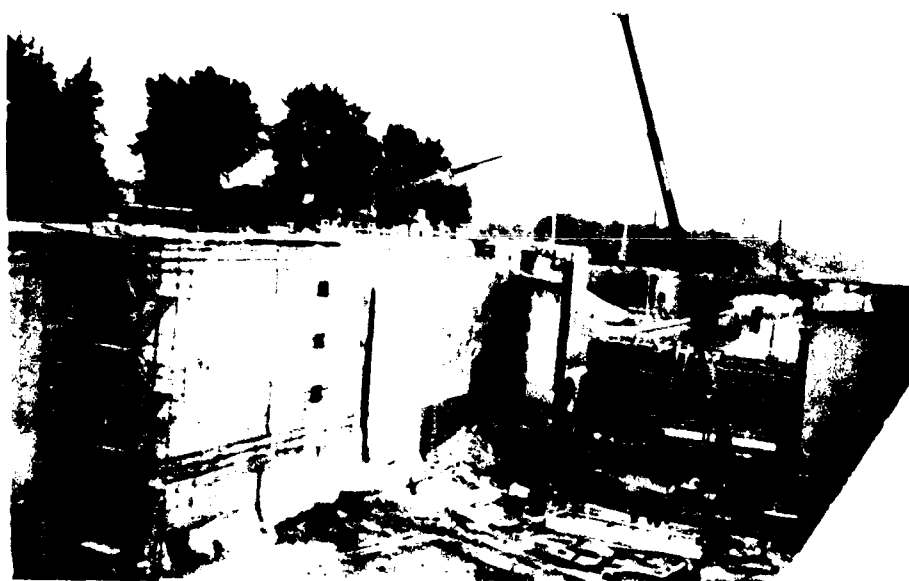
Figure 183. Blasting mat in position behind the lower miter
gate for limited concrete removal, Brandon Road Lock

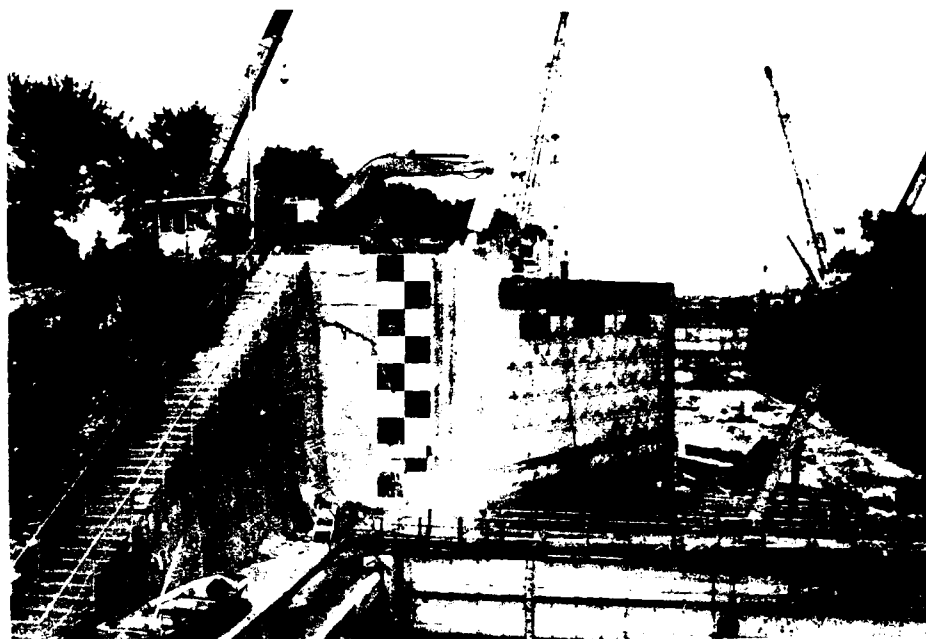
Figure 184. Cutter head removing concrete which had previously been fractured using expansive grout, Brandon Road Lock

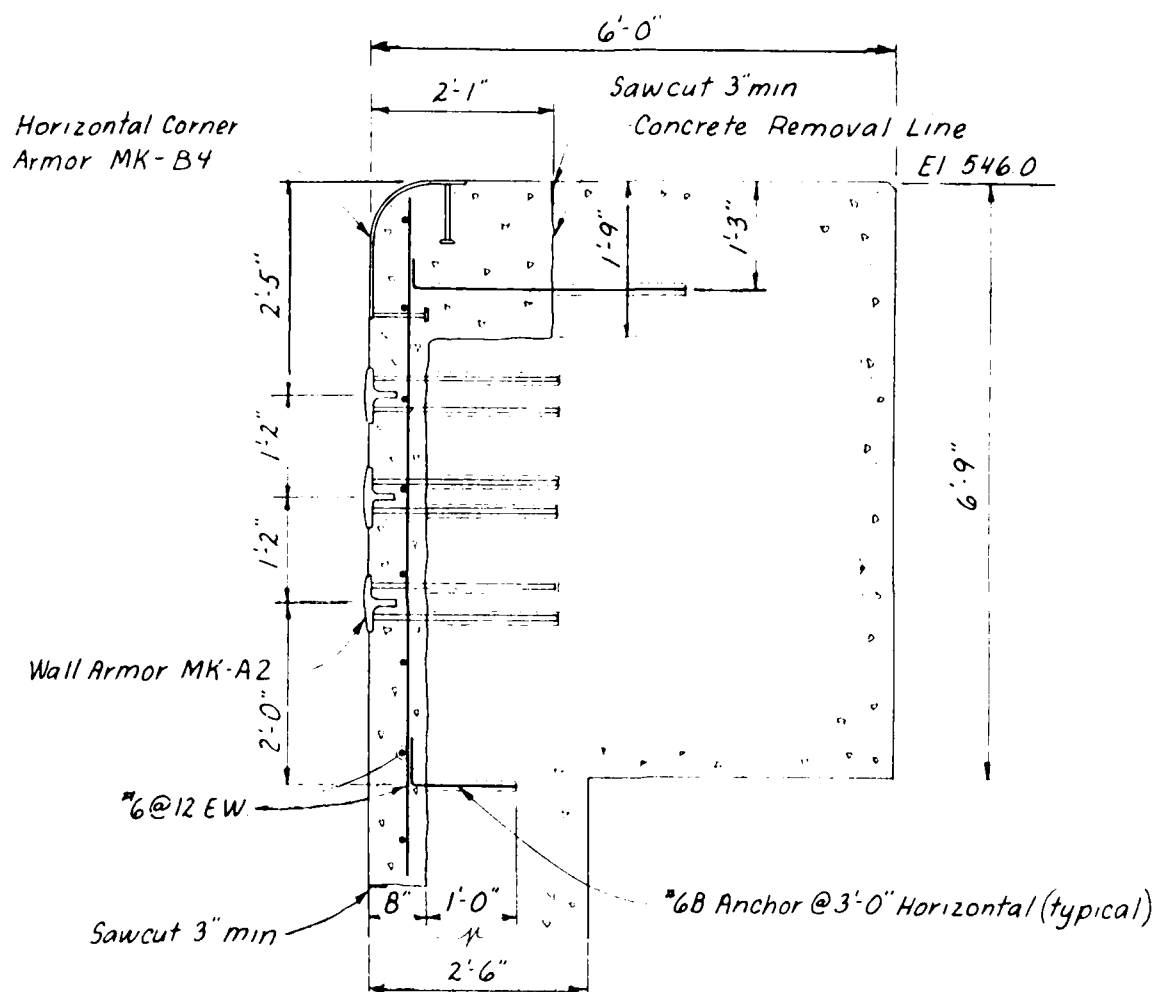
Figure 185. Upper guide wall resurfacing details, Brandon Road Lock

343. The top 8 ft of the river face of the upper guide wall was resurfaced with a nominal 8 in. of new concrete. This work required removal of approximately 225 cu yd of existing concrete. New wall armor and horizontal corner armor were installed as shown in Figure 185. Typical views of the

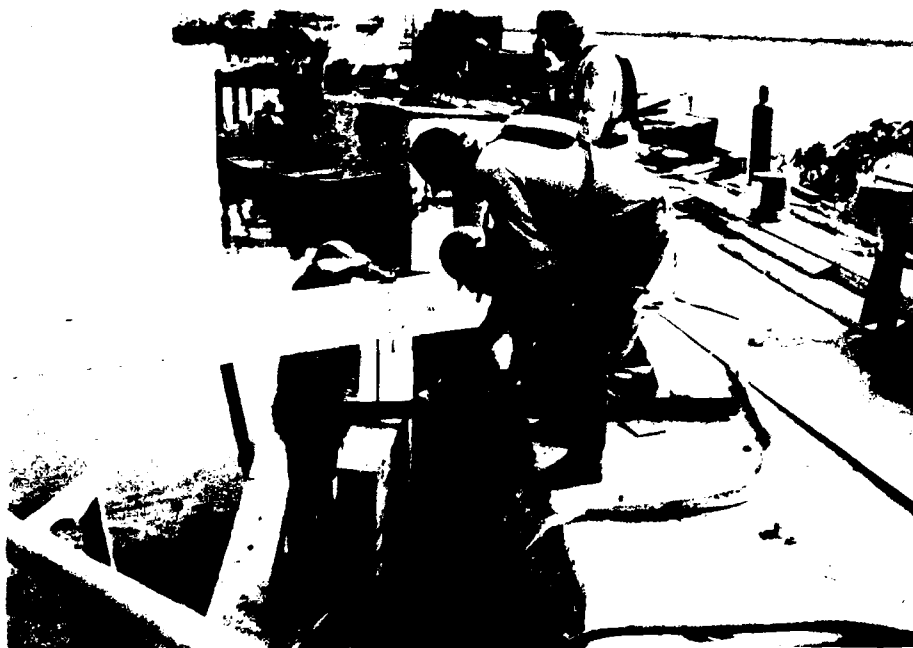
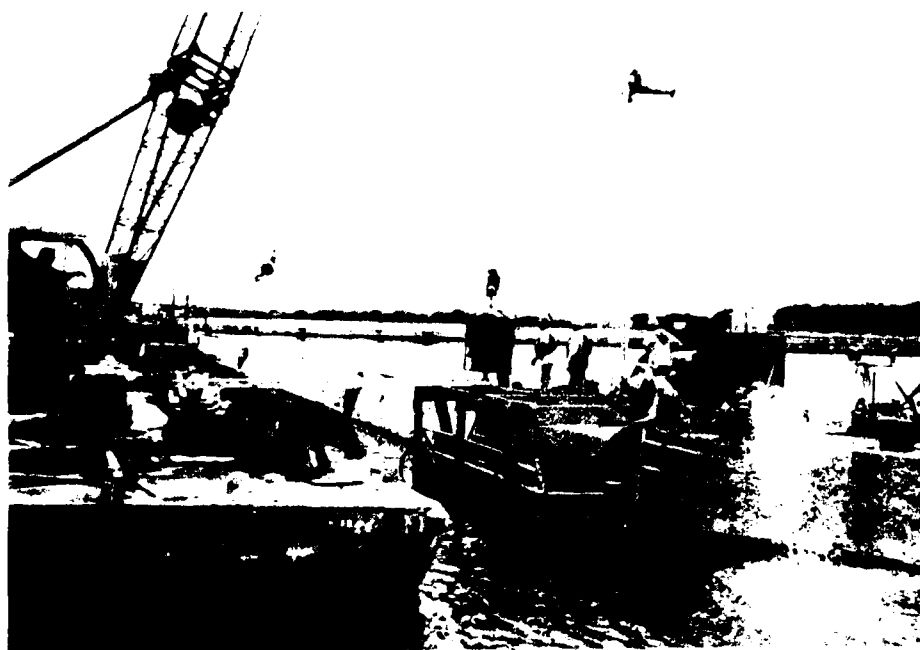
Figure 186. Upper guide wall and gate bay resurfacing,
Brandon Road Lock

resurfacing operation are shown in Figure 186. Type C concrete was used to reface the upper guide wall. Approximately 2 to 3 in. of concrete was removed from the top surface of the guide wall and replaced with an overlay of latex-modified concrete (approximately 17 cu yd). Latex-modified concrete (Figure 187) was specified in an attempt to reduce the shrinkage cracking problems inherent with conventional concrete overlays. The latex additive made the concrete surface very sticky and thus caused some finishing problems.

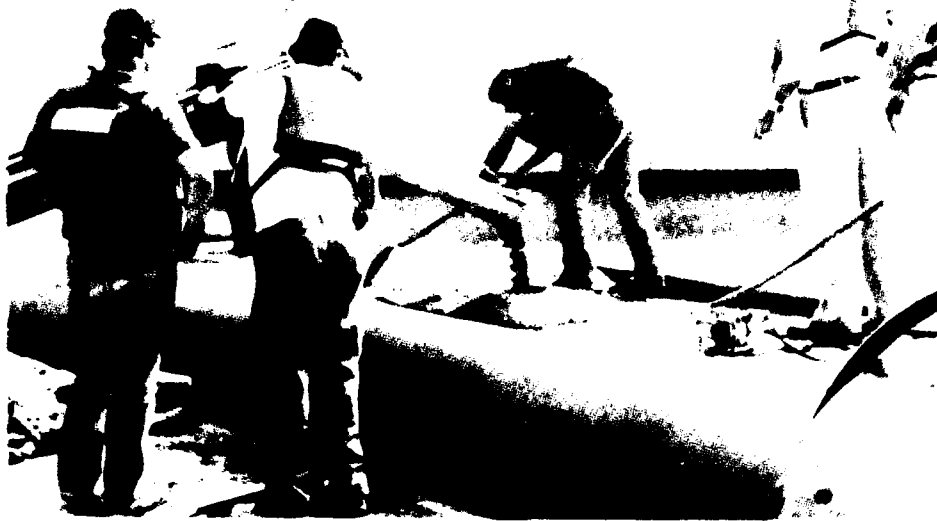
Figure 187. Resurfacing top of the upper guide wall with latex-modified concrete, Brandon Road Lock

However, the latex-modified concrete has performed well with a minimum of cracking. The contractor's bid price for latex-modified concrete was \$750 per cu yd, and the total bid price for resurfacing the upper guide wall was approximately \$350,000.
